Short description of the first tests for integrating the new CO₂ sensor from Licor (LI7815) into the pCO₂ system from General Oceanics

Last changed: 11. March 2020

ICOS OTC 2020

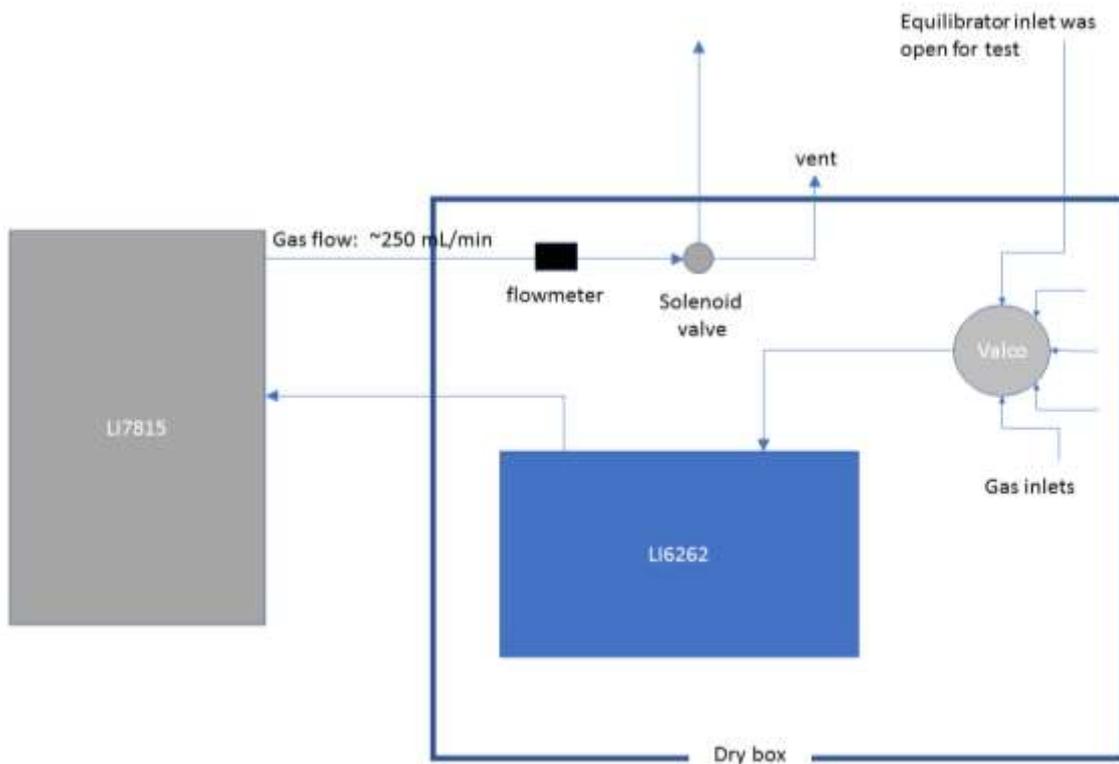
Figure 1: Schematic of connections for the LI7815 within the GO system in series with the LI6262. Please note that, for the beginning of our tests, the dry box was not connected to the wet box.

The instrument was connected in-line with the LI6262 in the GO system (Figure 1) and first tests were performed. This was mainly to adjust the GO software to deal with the LI7815.

Since the LI7815 works with a cavity that operates at ca. 400 mbar, a vacuum pump is used inside the instrument (see Figure 2). In order to test for leaks in the pump, the LI6262 was connected downstream of the LI7815 to detect leaks in the LI7815 that are behind the cavity. When running the zero gas, we blew inside the dry box and LI7815 to provide a high CO₂ atmosphere. The signal at the LI6262 was observed for possible peaks, but it stayed constant. Afterwards, the systems were connected as shown in Figure 1.

After the test onboard Littorina, the system was setup in the lab (as shown in Figure 1) and standard gases were connected:

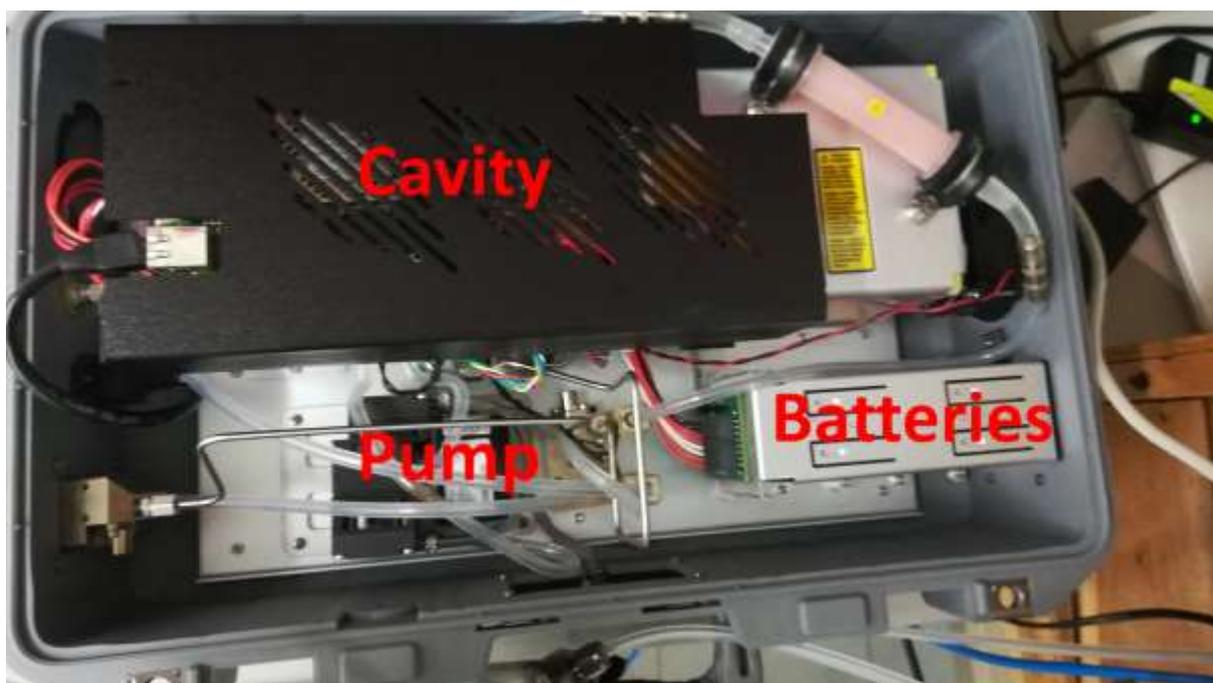
Figure 2: Inside view of LI7815. Each component can be removed separately.

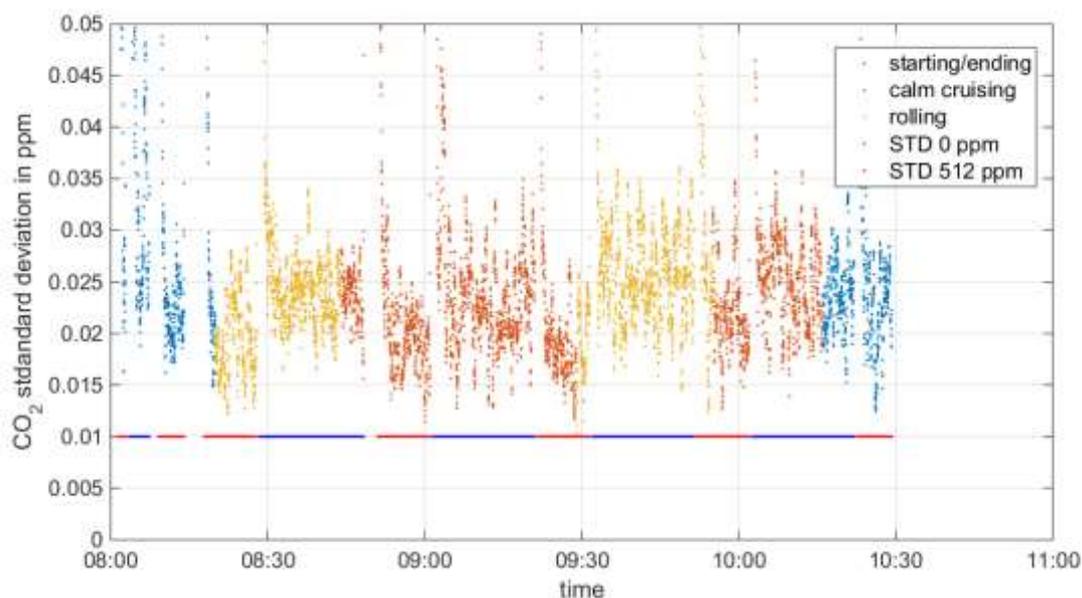
Figure 3: Standard deviation of CO₂ values averaged over 20 seconds during the rolling experiment onboard Littorina. The data are color coded for the periods where the ship was moving out of/into port and for the times where the ship was heavily rolling or calmly sailing. The color code of the line at 0.01 denotes the standard gas that was measured. The higher values above 0.035 ppm are from the period after the standard gas was changed, which typically leads to a higher standard deviation.

On June 07, the dry box of the GO system was installed onboard the research ship “Littorina” (length: ca. 30 m). Since the weather was calm, we induced ship roll by maneuvering in a criss-cross pattern through the Kiel bight while measuring 2 standard gases STD1: 0 ppm (CO₂ free air), 512.6 ppm (in natural air). The results are shown in Figure 3.

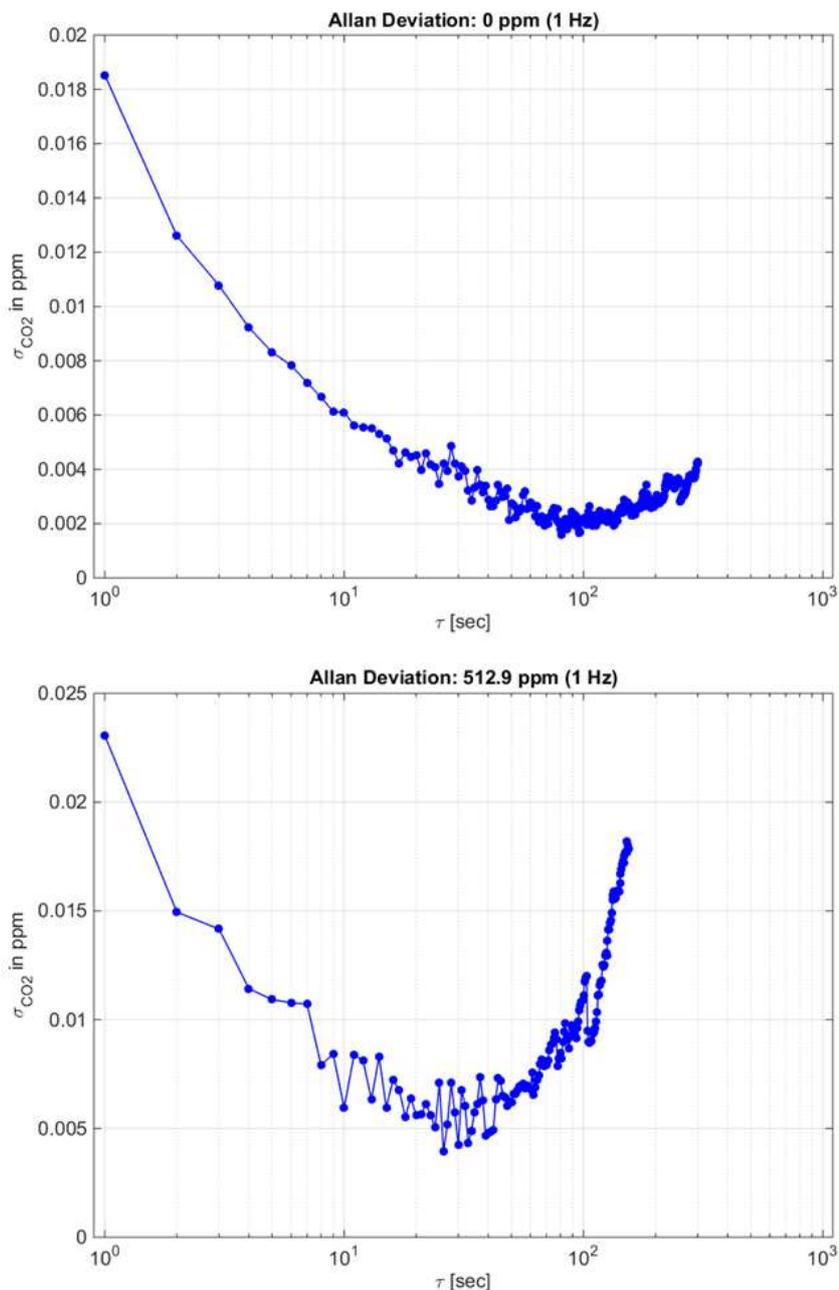
Figure 4: Allan deviation plots for CO₂ measurements at 1 Hz. The upper panel shows data for measuring the zero standard and the lower panel shows data from measuring the standard gas with 512.9 ppm CO₂.

To estimate the optimal averaging time, two standard gases were measured for approximately 20 minutes. First the gas with 0 ppm CO₂ was measured and then the gas with 512.9 ppm CO₂. Figure 4 shows Allan plots for both gases. The result compares very well with the Allan plot shown by Licor in their report, which can be found here: https://www.licor.com/env/products/trace_gas/.

The results indicate that for both concentrations an averaging interval of 10 seconds is sufficient to reduce the measurement uncertainty of the instrument below 0.01 ppm.

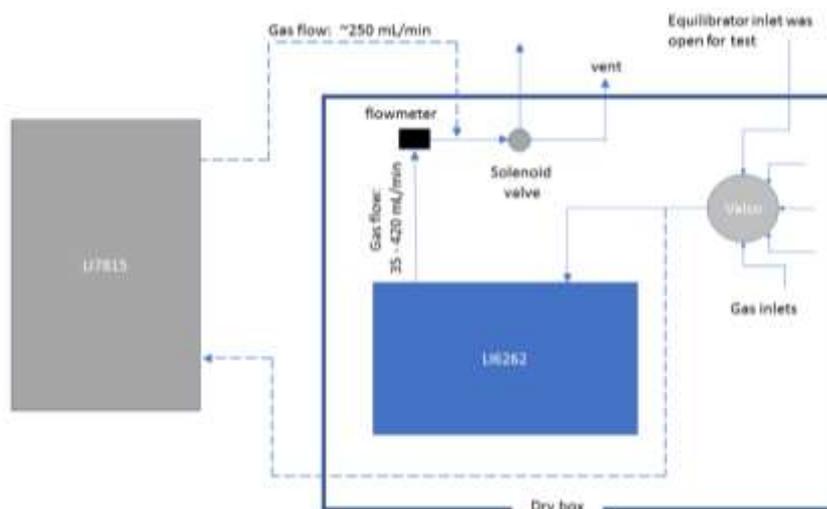
Figure 5: Schematic of connections for the LI7815 to the GO system in parallel configuration. The wet box was not connected.

The LI7815 circulates the gas at a flow rate of approximately 250 mL/min. The GO system was originally designed for a gas flow of about 100 mL/min. In order to reduce the flow through the equilibrator and drying unit/Nafions and to reduce the gas flow of the standard gases we connected the two instruments in parallel (Figure 3).

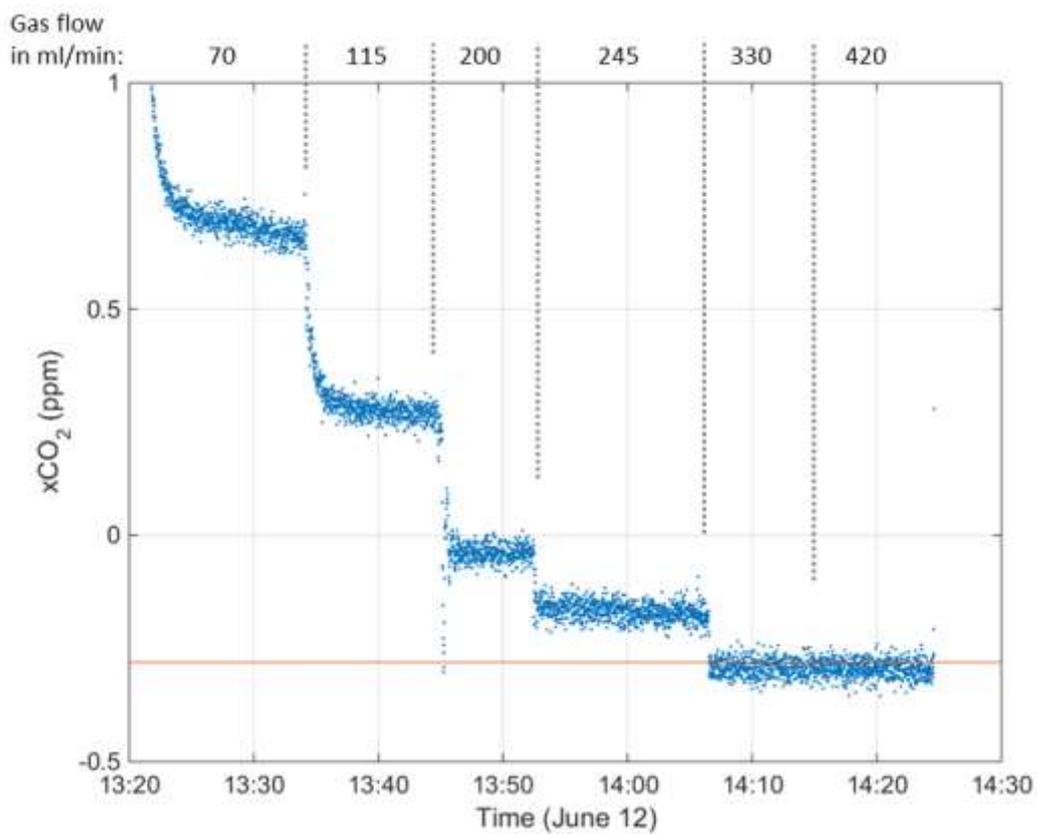
Figure 6: CO₂ readings of the LI7815 for different gas flows at the GO system. Both sensors (LI7815 and LI6262)9 were connected in parallel. The red line shows the approximate values for the zero standard measured before and after this test, when the sensors were connected in series.

Zero gas was used for the test and the flow was adjusted using the needle valves before the Valco valve. Figure 6 shows the resulting CO₂ readings of the LI7815. As long as the gas flow was smaller or close to the gas flow in the LI7815 (250 mL/min), the system did not reach the zero value. Once the flow was higher than 250 mL/min, the system went to the zero values that were measured before and after this test (i.e. when the instruments were connected in series).

The parallel connection is not a solution, as the gas flow needs to be even higher than 250 mL/min. The instruments were connected, therefore, again in series after this test.

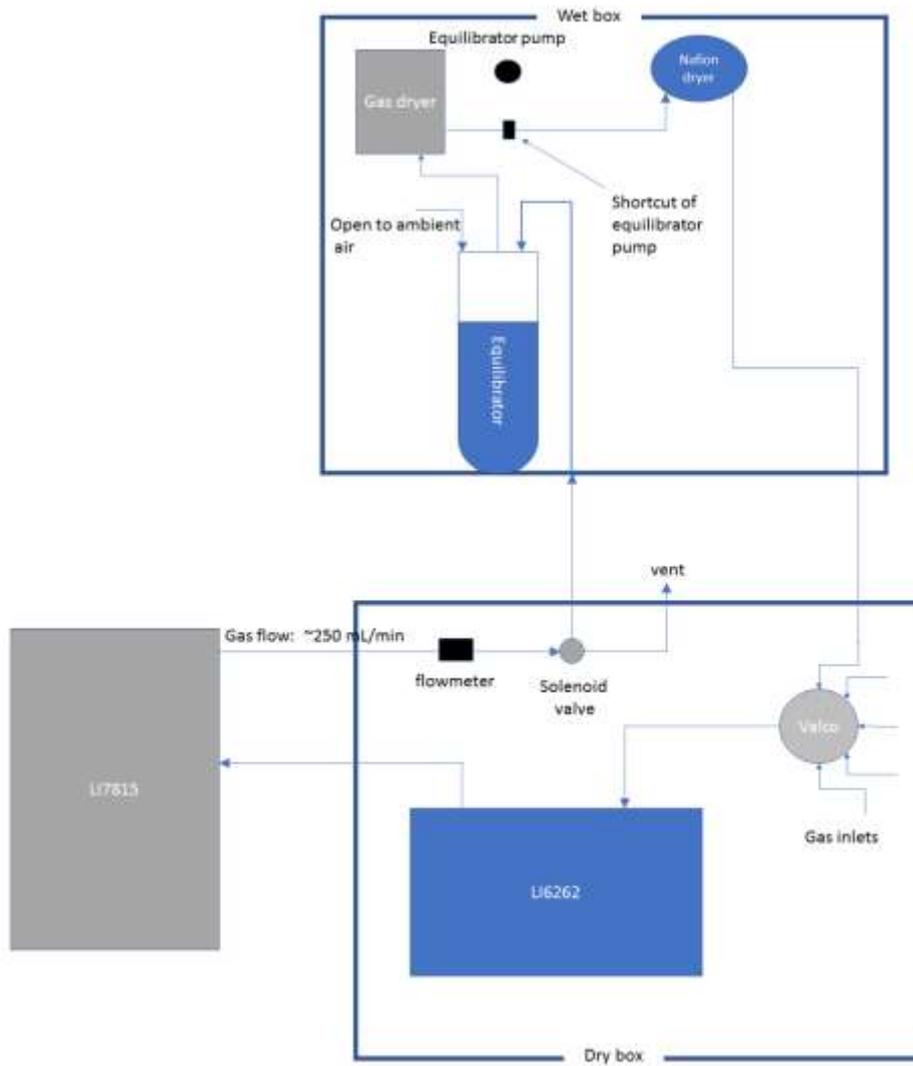
Figure 7: Schematic of connections for the LI7815 to the GO system in serial configuration with the wet box connected. The equilibrator pump of the GO system was bypassed.

The wet box was connected to the dry box as shown in Figure 7 to mimic shipboard applications. On **June 14** the zero and span values were readjusted (only minimal changes were done).

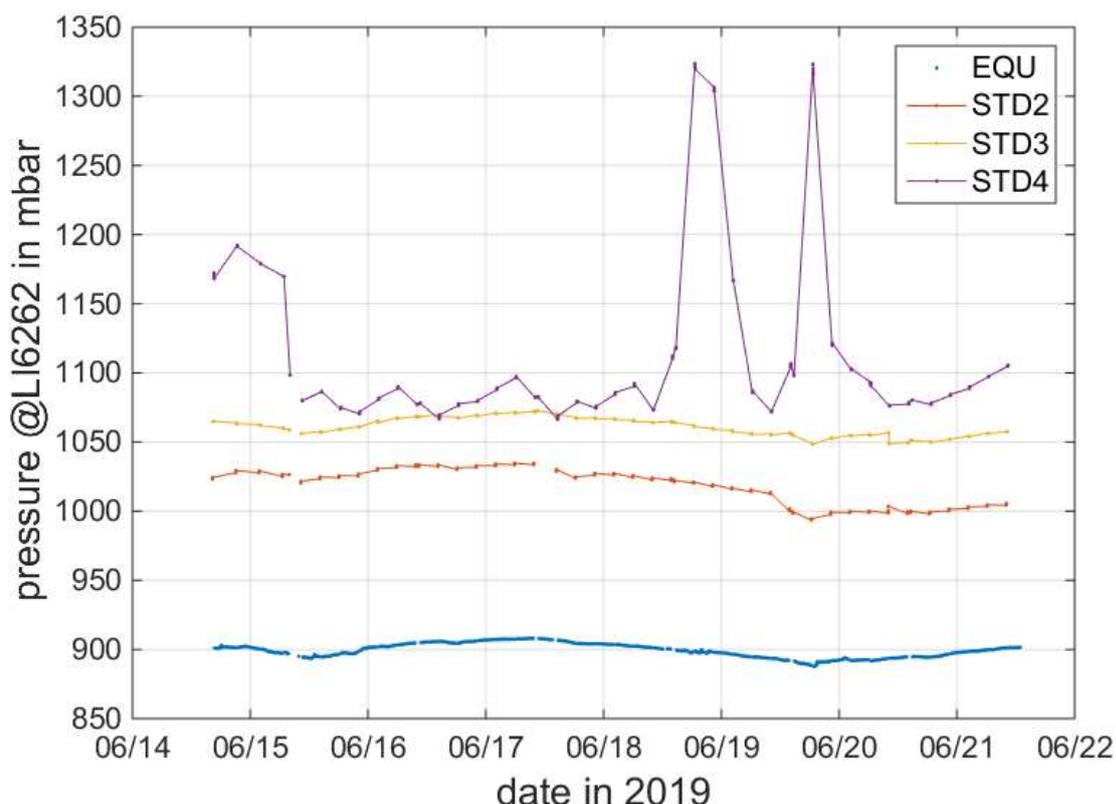
Figure 8: Pressure readings before the LI7815.

Figure 8 shows the pressure readings for the whole test. STD4 shows large deviations from the certified value. The gas bottle was nearly empty (~10 bar left) and the gas regulator was old, so we assume that the regulator was the problem.

The pressure was around 900 mbar when measuring equilibrator air, which was approximately 100 mbar below atmospheric pressure. The standard gases needed to be adjusted well above this level to ensure enough gas flow in case of changing conditions.

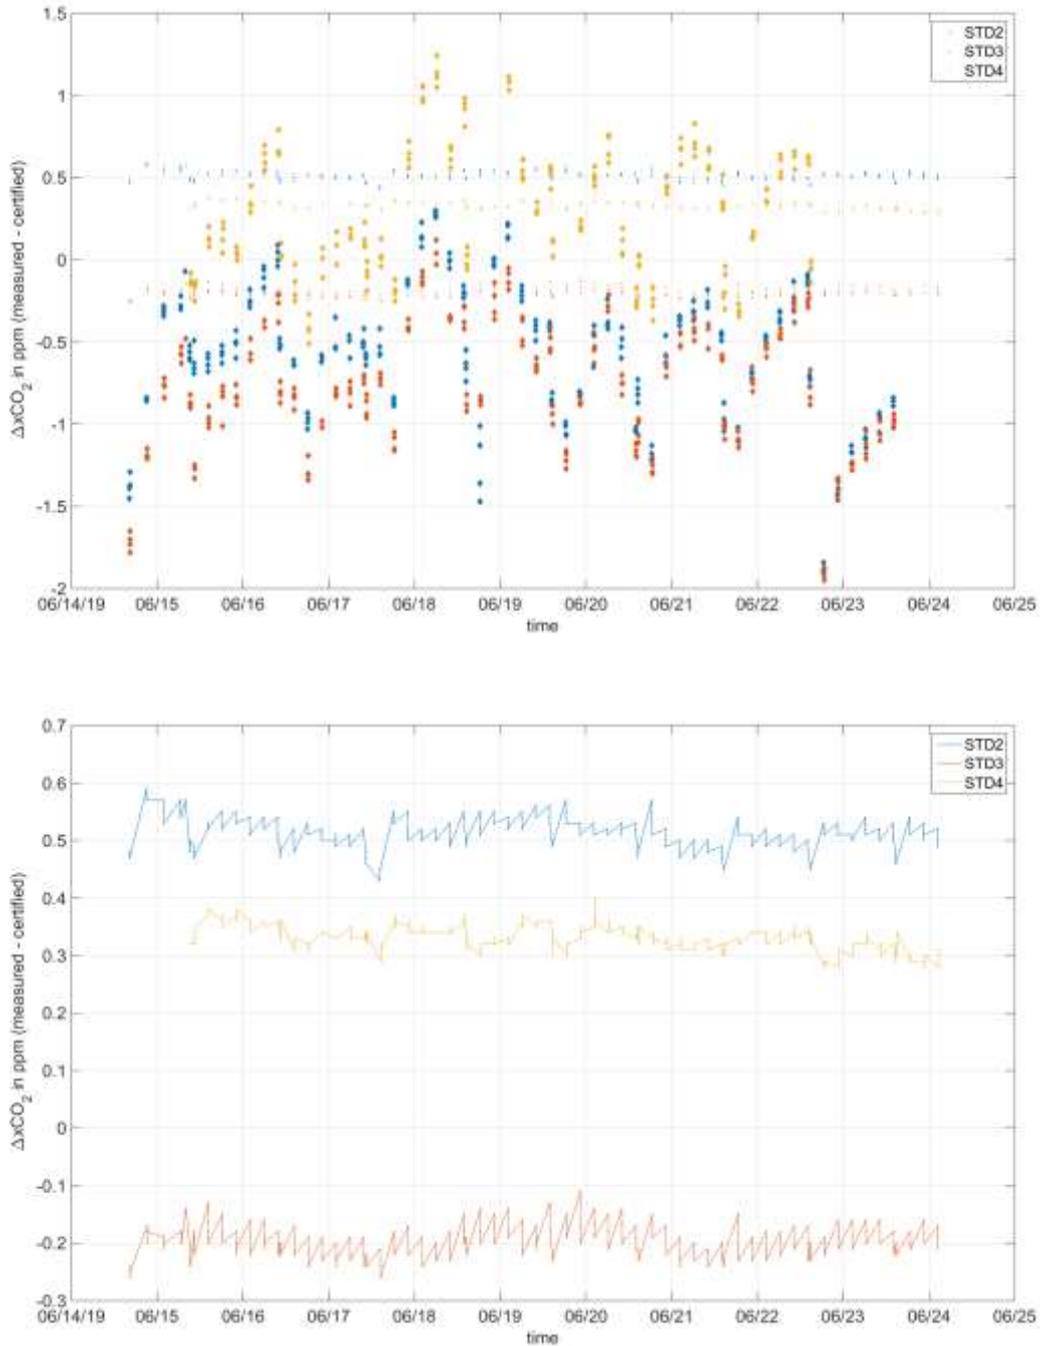
Figure 9: Data from standard gas measurements with the LI6262 (upper panel) and LI7815 (lower panel). The difference between the measured and the certified value for all three non-zero standard gases is shown. The standard deviation for measurements with the LI7815 is: $\sigma(\text{STD2}) = 0.028 \text{ ppm}$, $\sigma(\text{STD3}) = 0.026 \text{ ppm}$, $\sigma(\text{STD4}) = 0.022 \text{ ppm}$.

Figure 9 shows the standard gas measurements with the LI6262 and LI7815. There are 4 consecutive measurements each time a standard gas was measured. The first measurement for the LI7815 was always between 0.04 and 0.09 ppm higher than the last three measurements. As mentioned above, the zero and span of the LI7815 was not adjusted during the time period shown (approximately a week) and the instrument was stable within approximately 0.1 ppm. The standard deviation of the standard gas measurements was for all three gases below 0.03 ppm (see Figure 9). This includes also a possible drift over the week.
